## TW5-TVR-AIA

### Task Title: ARTICULATED INSPECTION ARM (AIA)

## Task Title: RADIATION TOLERANCE ASSESSMENT OF STANDARD ELECTRONIC COMPONENTS FOR REMOTE HANDLING

## Task Title: DEVELOPMENT OF A WATER HYDRAULIC MANIPULATOR

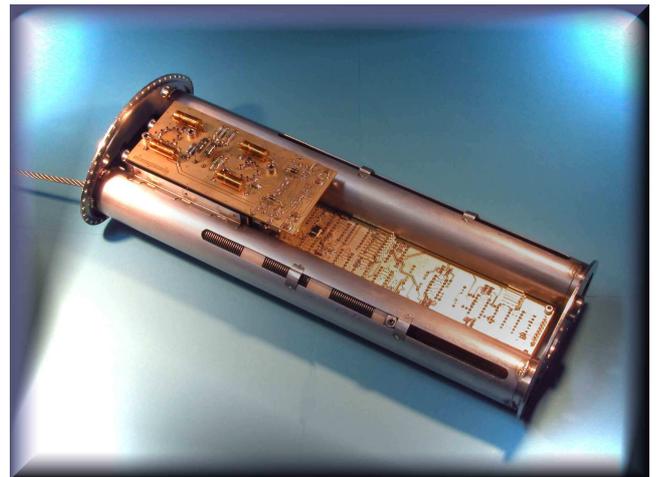
The main modifications are located on the rotation actuator box:

- Thickness increase, to allow leak detection and a better stiffness,
- Neurobot board integration with gold coating,
- Sealing is provided owing to aluminium joint whether welding.

Figure 1: Rotation actuator box

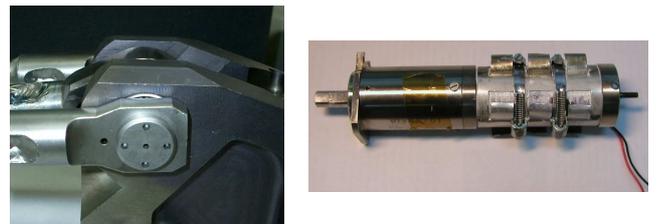
A motor cooler was added to improve heat conduction. New rods are made in stainless steel plains bars.

Figure 3: New rods and motor cooler
